## 5.2 E0/F4 (EEPROM parameter error)

**Description:** Indoor or outdoor PCB main chip does not receive feedback from EEPROM chip.

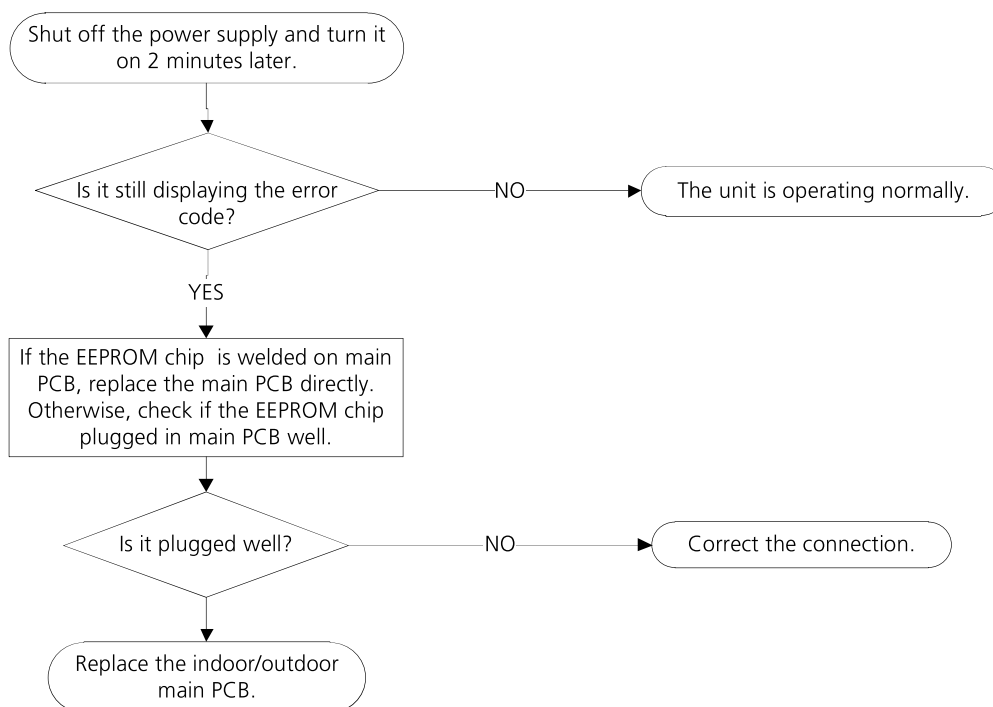
**Troubleshooting and repair:**

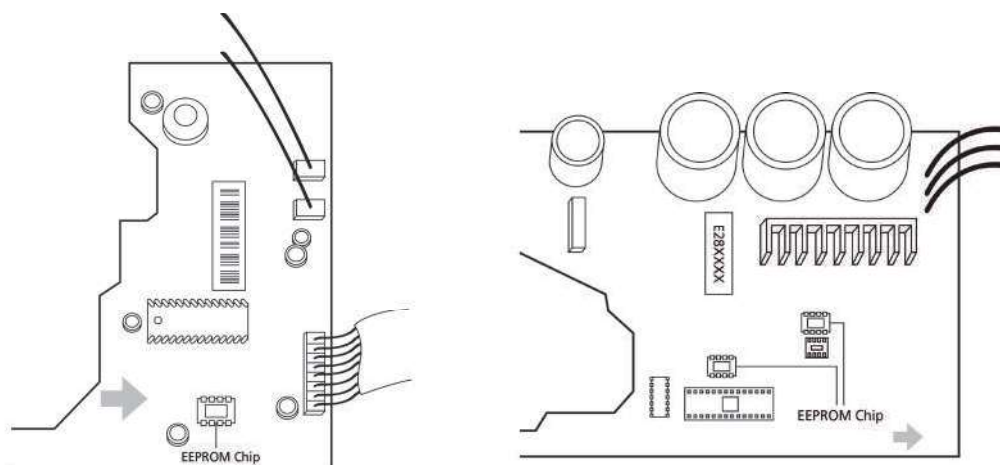
The location of the EEPROM chip on the indoor and outdoor PCB is shown in the following two images:

**Note:** These images are for reference only.
